28th International Conference on Lightning Protection

Lightning protection of a cable-stayed bridge

A. Rousseau, SEFTIM¹, L. Boutillon, VINCI Grands Projets², A. Huynh, FREYSSINET³

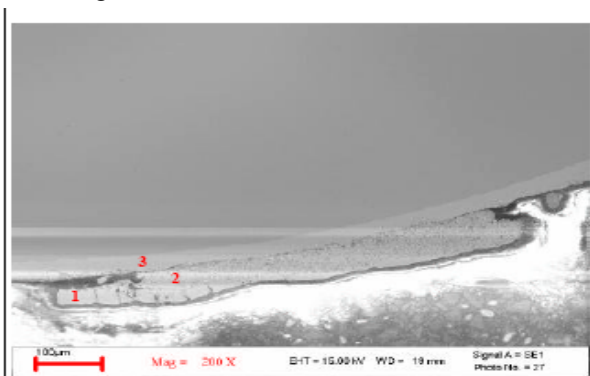
Fig. 1. Detail of the porous area made of zinc located at the observed marks. Grey zone at the top is made of steel (no alteration).

Inspections and tests enabled to conclude that the direct damages induced by the lightning strike were limited to the zinc layer (melting) without affecting the steel of the wires.

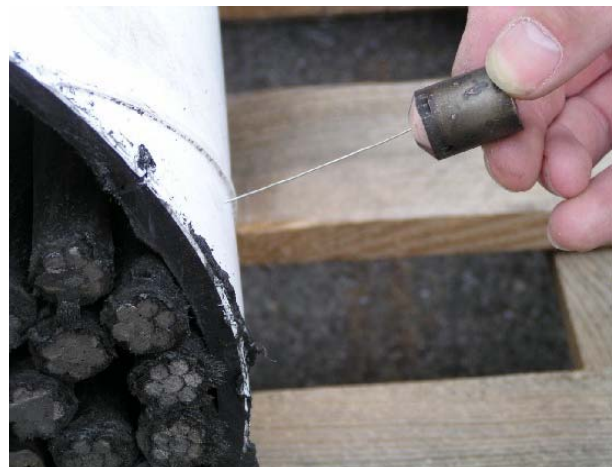
Fig. 2. Fuse wire connected to one of the strand inside the duct

First tests have been performed with the copper wire directly in contact with the strands outside of the duct. After a few seconds the fire stops even for charges as big as 680 C !

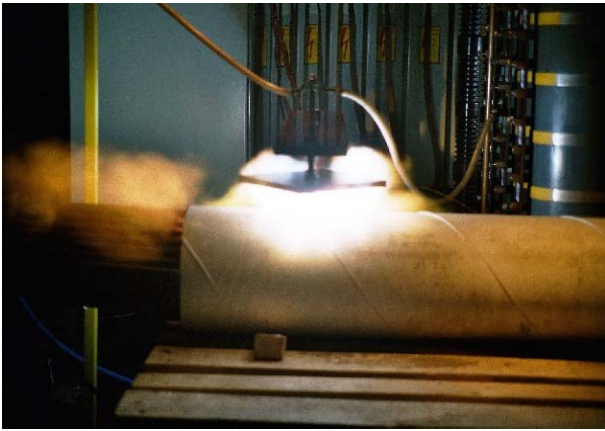
Fig. 3. Tests performed on the free length.

Then we performed tests on a complete assembly reproducing the top stay cable. Tests performed over the free length confirmed the expected high fire resistance. Even tests made of combination between high impulse current (up to 50 kA) as per IEC 62305-11 and long duration (up to 680 C) lead to stop of fire after 5 s. Tests in vicinity of the collar led to results similar to those obtained during the flame tests. It was needed to have both a 500 C current and a 10 mm diameter hole to generate a small fire which did not self-extinguish and that we had to stop manually.

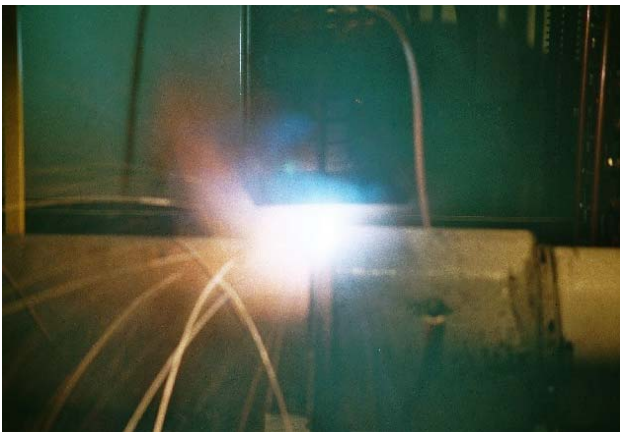
Fig. 4. Tests performed near the collar.

The upper stay cable has been struck very likely by a lightning flash nearby its upper collar, on the upper side, which was an attracting point.

The flash was powerful enough to punch the HDPE outer duct of the stay cable creating a hole larger than 10 mm in diameter. It has then impacted the strands in at least eleven locations, generating a superficial melting of the wires zinc layers. The conditions near the collar and the

electrical charge transferred were such that a small fire was ignited at the edge of the hole in the HDPE duct. Despite the wind and the probable rain, the combustion did not stop. Once the fire of the duct was strong enough to burn by itself, the heat was transmitted to the steel strands.

- Use fire retardant material in the vicinity of the collar to modify the local conditions and to prevent the fire from starting
- Reduce the number of potential flashes to the top stay cables by installing stretch wires above them.
- Try avoiding collars to be preferential impact points

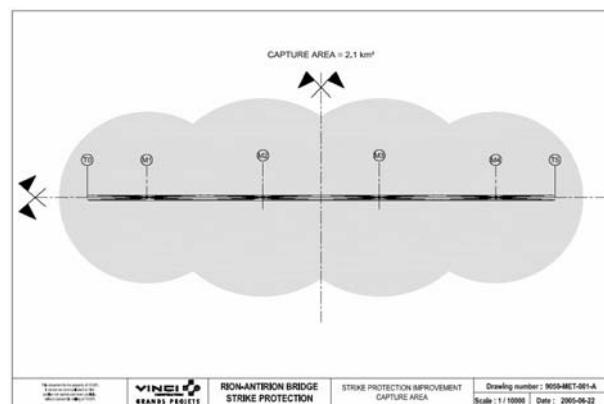
The lightning capture area for the whole bridge has been determined in accordance with IEC 62305-2 and is equal to 2.1 km², see Figure 5. As this part of Greece as a keraunic level around 30, the expected number of lightning flashes is around 6,3 per year. The expected number of flashes to the stay cables has been estimated in the same way to be 4 per year. Surges counters installed on the down-conductor suggest that at least 21 lightning strikes hit the pylons from August 2004 to June 2005.

Fig. 5. Calculated capture area.

This is 3 times bigger than what we could be expected from the keraunic data. New surge counters measuring current, charge and having time stamp will be fitted to better determine in future what is the exact number of lightning flashes to the pylons.

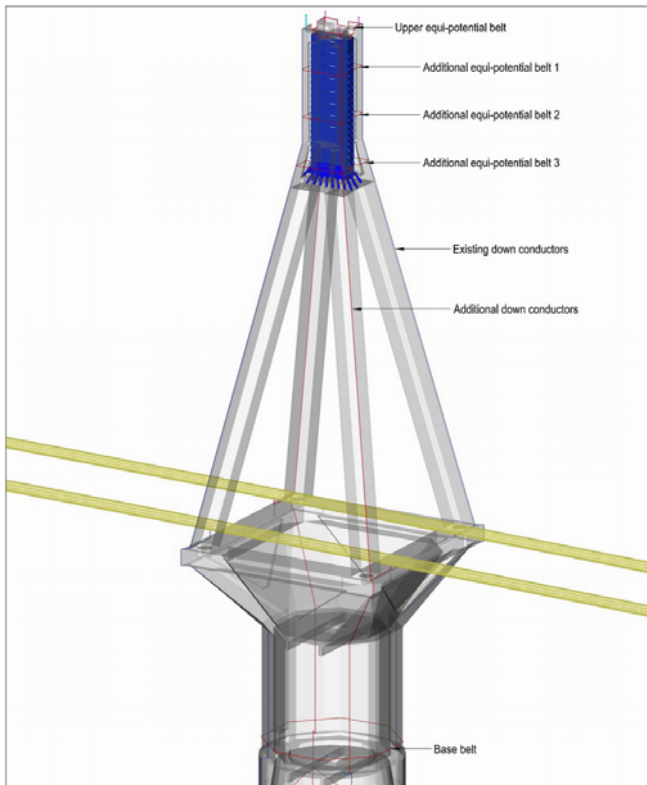
Fig. 6. Enhance pylon protection

As it was likely that corner and edge of the top part of the pylon be the preferential attachment point, a ring conductor with 4 rods at each corner have been installed. Two additional down-conductors have been also implemented to make a mesh as well as 3 more ring electrodes evenly spaced from top of the pylon to the bottom of the metallic stay cable anchorage box. Another ring conductor has been installed at sea level to share the current between 4 earthing systems. Equipotential bonding of pylon metallic part has also been provided (see Fig. 6).

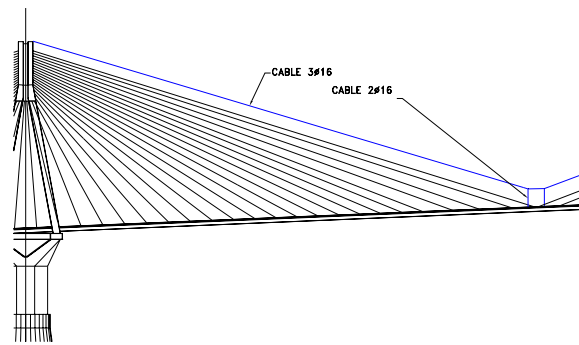
Fig. 7. Stretch wire and stay cables

Stainless steel high strength strands have been used to build a stretch wire above the top stay cables, connected to the pylon mast upper ring conductors. The stretch wire is running parallel to the upper stay cable and is connected at mid-span to a central piece which is attached by hangers to the deck. The tension in the stretch wire is close to the tension in the stay cable strand so as to have similar deflections in order to ensure a minimum distance between stretch wires and stay cables. Safety distance has been calculated so that even in case of strong wind and lightning occurring at the same time the distance between the stretch wire and the upper stay cable always remain above the spark over voltage. At last redundancy ensures that no stretch wires can fall on the deck even in case of exceptional strike.
