## THE BEHAVIOR OF RION – ANTIRION BRIDGE DURING THE EARTHQUAKE OF “ACHAIA-ILIA” ON JUNE 8, 2008

**Panayotis Papanikolas**, Vice-Chairman and Managing Director, GEFYRA S.A. –  
Concession Company for the Rion-Antirion Bridge, Greece

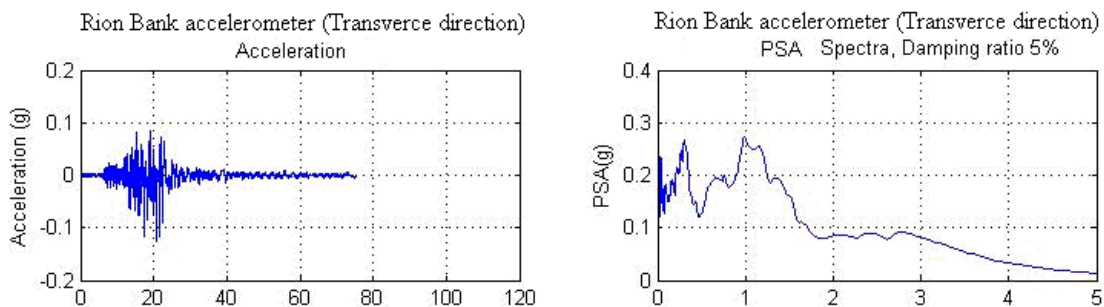
Fig. 7 Rion bank acceleration and PSA response spectrum

The maximum on shore acceleration was 0.127g recorded on Rion in the transverse direction of the bridge. It is interesting to notice the high values of PSA response spectrum around periods of 1 sec. (See figure 7)

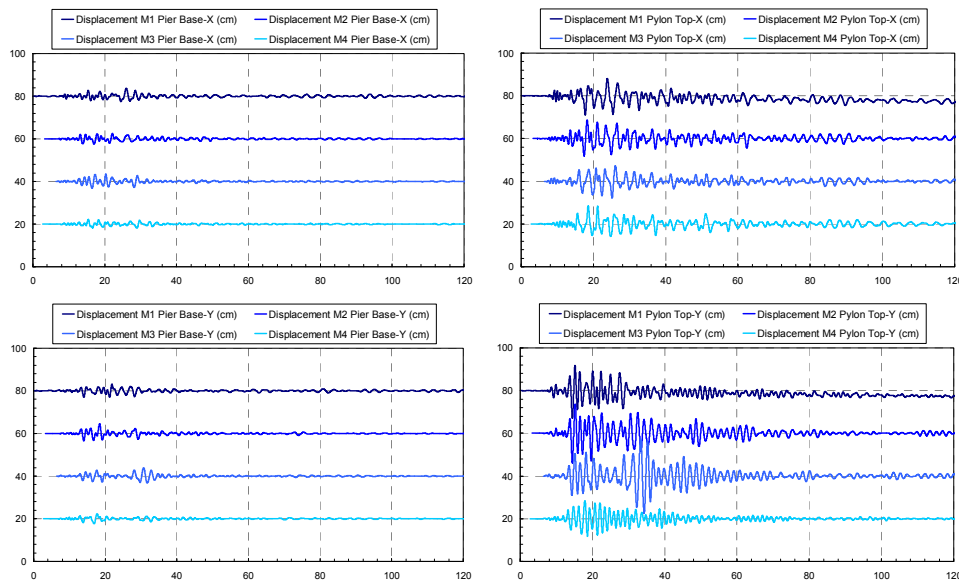
Fig. 8 Displacement on pier base and pylon top

It is interesting to notice that amplification of displacements is greater along the transverse axis (Y) of the bridge (magnification factor 4.9 on M3-Y) than along the longitudinal axis (X) (magnification factor 3.4 on M2-X).

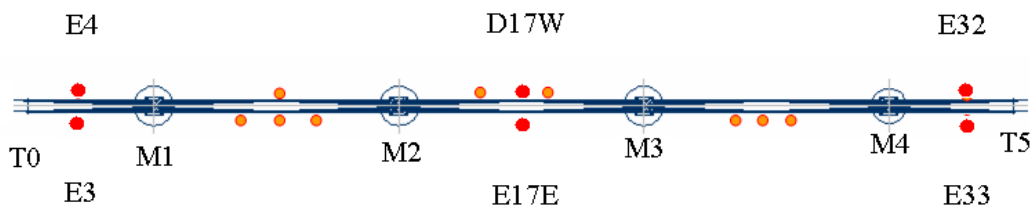
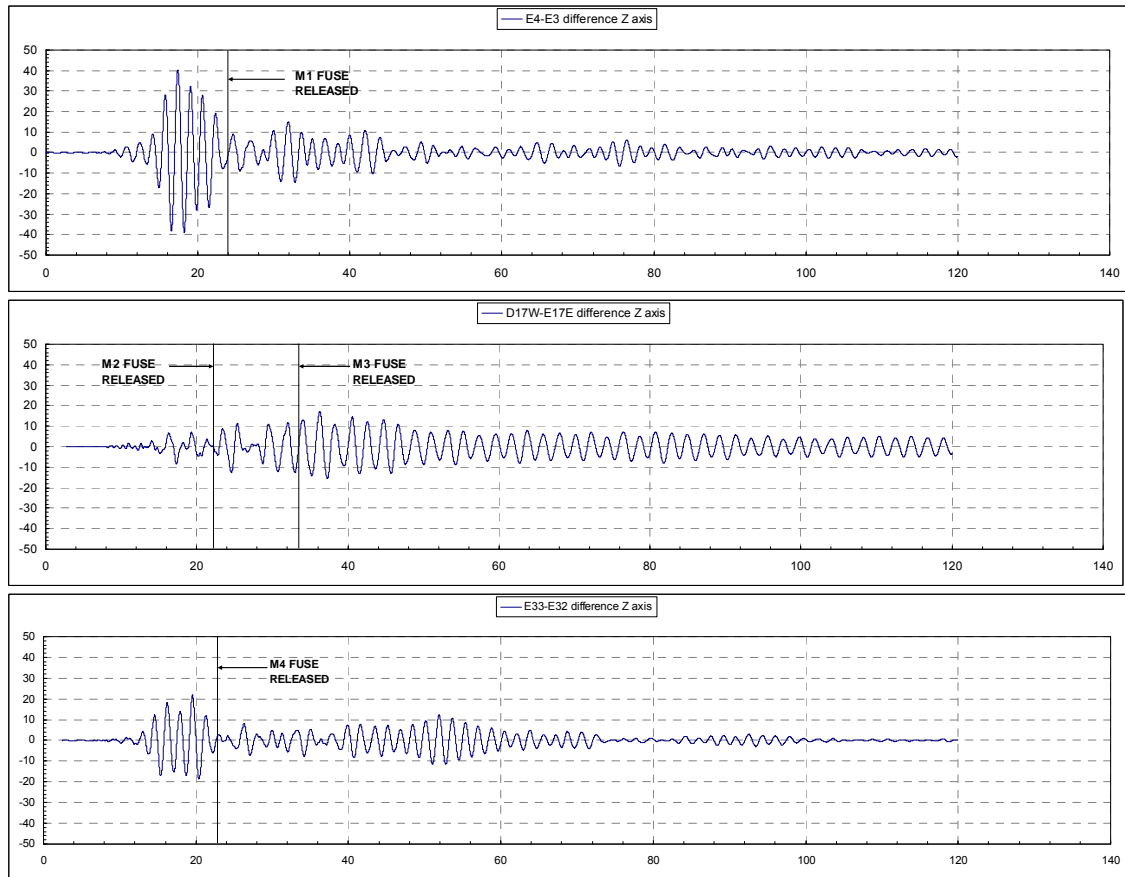
Fig. 9 Torsional movement of deck

Reduction of torsional deck movement is observed especially on the extreme spans (T0-M1) and (M4-T5) when the lateral restrainer yields.

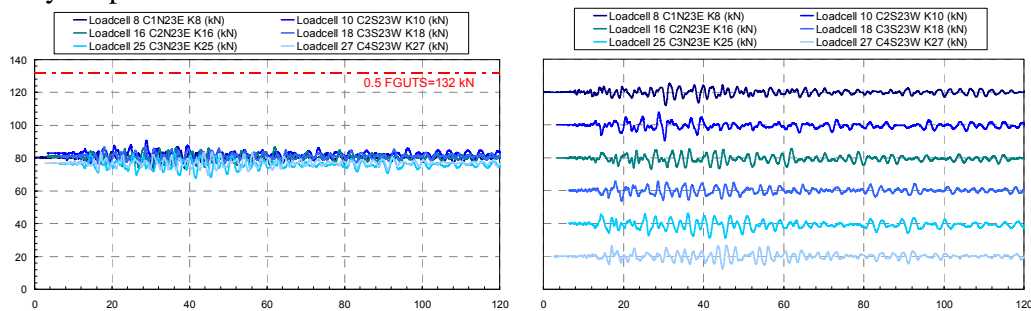
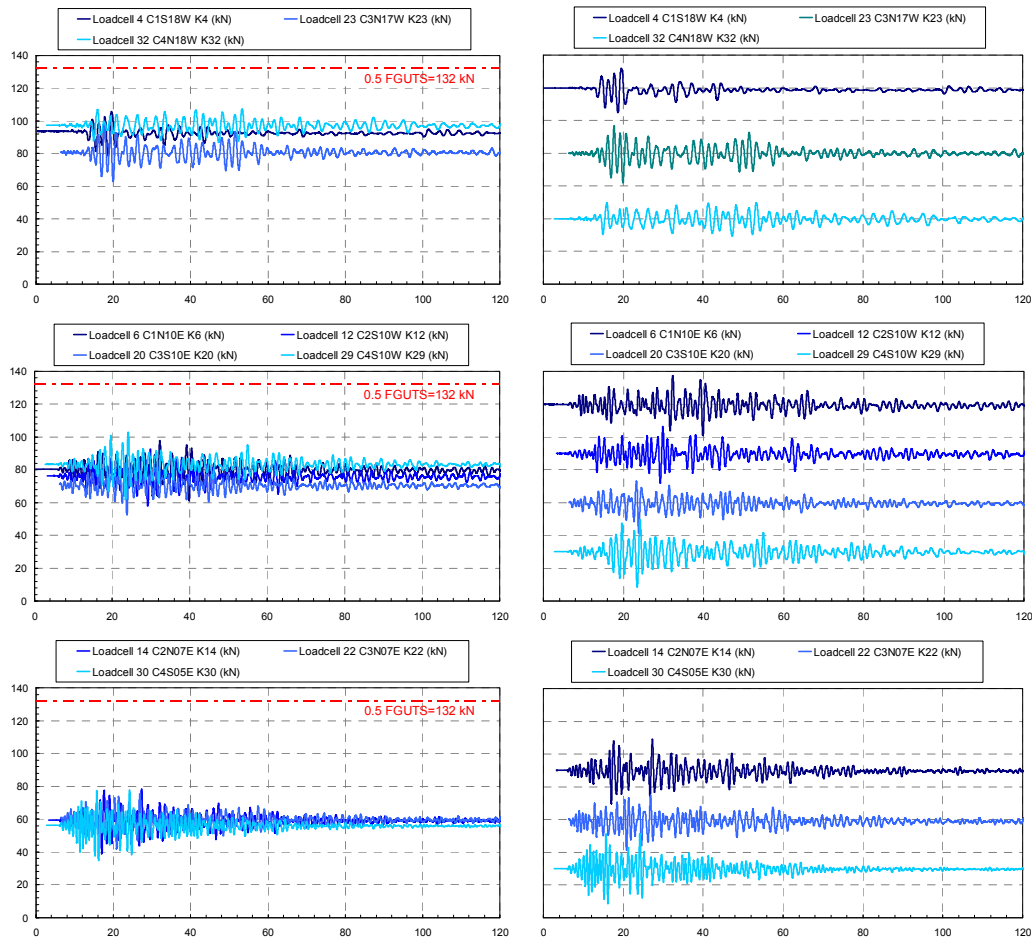
Fig. 10 Load on cable stays grouped regarding their length (shorter to longer)

The variation of the load on cable stays of the bridge remained well within the service limit state ( $0.5F_{GUTS}$ ) and also never fell below  $0.15F_{GUTS}$ . In the graphs of fig. 10 the load on cable stays is presented.

It can be observed that shorter cables have greater load variation than longer ones. This is due to the fact that longer cables have small inclined angle with the deck and thus are less sensitive to vertical and transversal deck vibration.

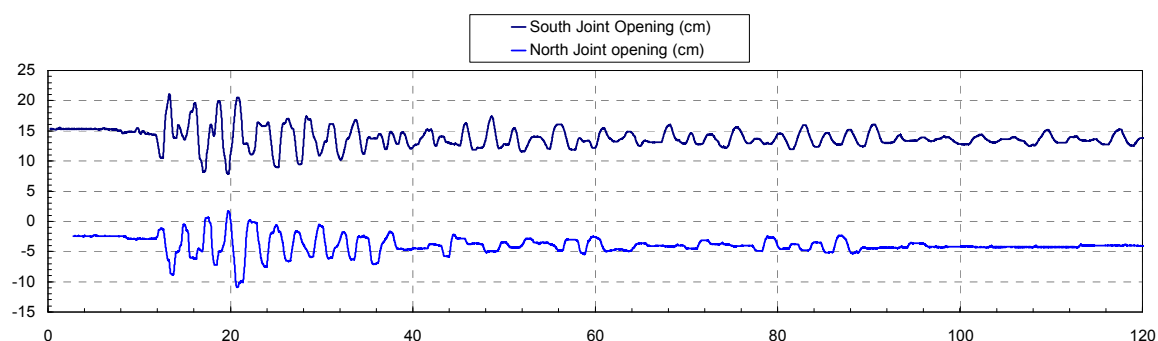
Fig. 11 Expansion Joint movement

The expansion joint movement on the extremities of the bridge did not exceed 14 cm in range, which is well below the maximum performance of the expansion joint in SLS (+126cm/-115cm)

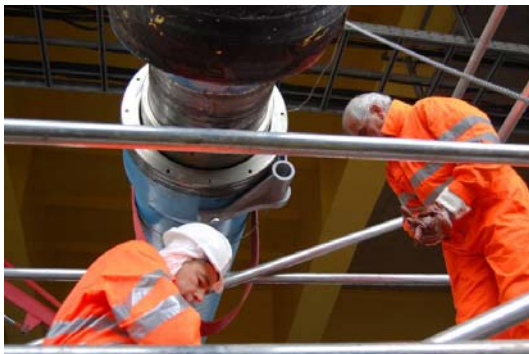
Fig. 17 Preparation for extraction of fuse device at pylons

Deck realignment works took place before the fuse replacement at abutments in order to adjust the deck at the target position. For this purpose a 100t jack was used. At the main piers the deck realignment was performed at the same time as the fuse replacement. Four hydraulic jacks were used.

It's worth-mentioning that the fuse replacement works (6 fuses) had duration of 2 weeks as it was forecasted.

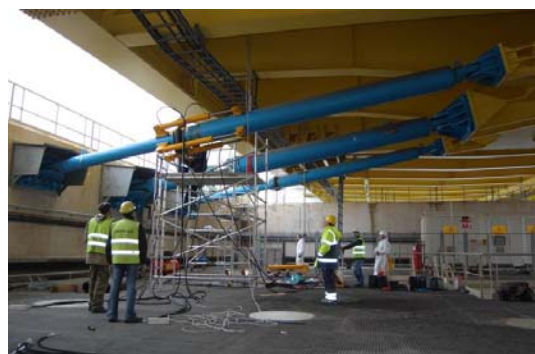
Fig. 18 Deck re-alignment & preparation for fuse replacement at pylons

The survey results have shown that no significant displacement occurred on the pylons since 2006 campaign. For this reason it was decided to realign the deck at the position of 2006.
